Rattlesnake Creek Conceptual Rehabilitation Plan

Prepared for:
Asotin County Conservation District
720 6th Street, Suite B
Clarkston, WA 99403

Prepared by:
Sage Environmental Research, LLC
February 2018

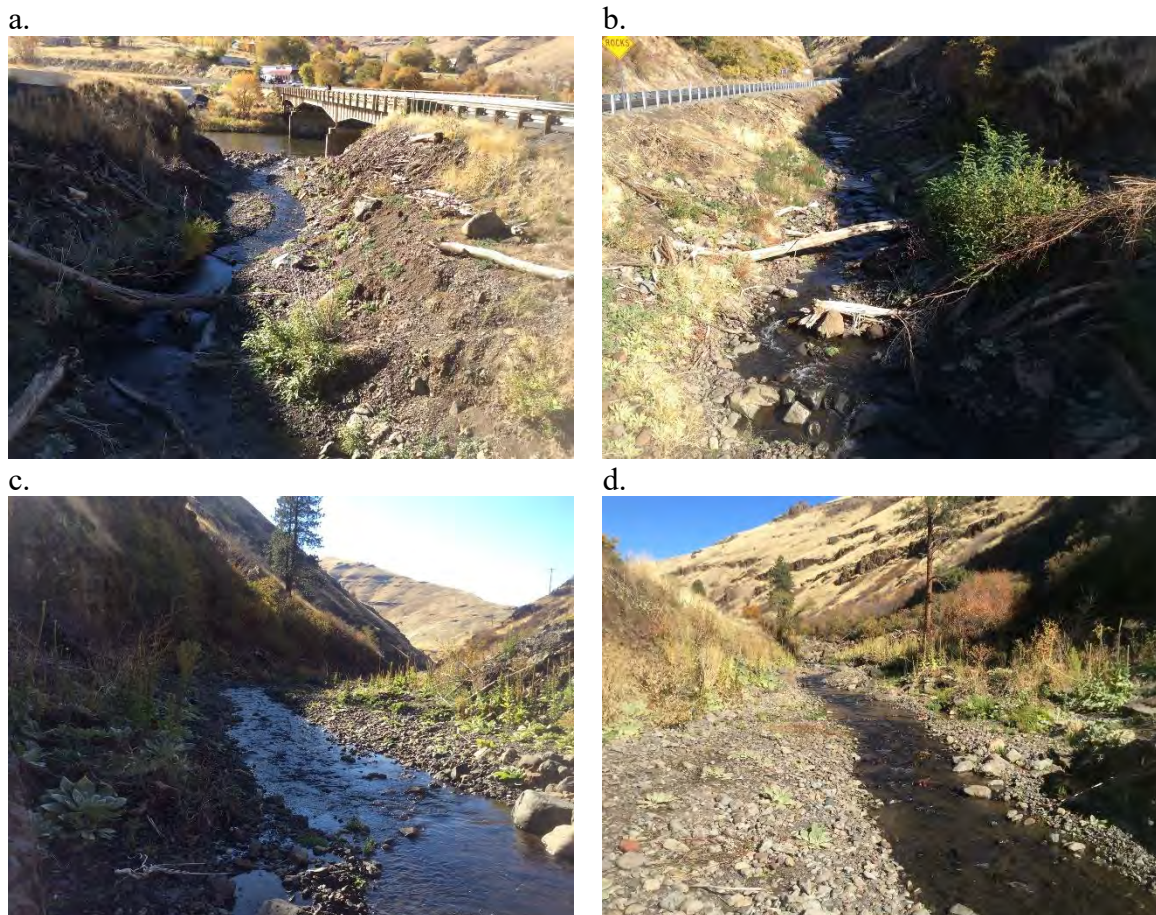
The lower 0.2 RM is more confined and incised than the upper 0.3 RM, with only a few floodplain pockets (Figure 2a and b). The upper 0.3 RM is slightly wider, has a lower gradient, and more opportunities for floodplain access and development (Figure 2c and d). A fan consisting primarily of boulders and large cobble has developed at the bottom of this reach and extends into the main channel of the Grande Ronde. The riparian area is devoid of canopy species and invasive herbaceous plants are the dominate vegetation.

Figure 2. Project Area 01 of Rattlesnake Creek looking towards the Grande Ronde confluence (a), upstream from the Grande Ronde confluence (b), and looking downstream (c) and upstream (d) near RM 0.4.

Recommendations for PA-01 are to remove the barrier caused by the fan at the Grande Ronde confluence, improve fish passage at potential boulder and bedrock barriers, move lodged LWD back into the channel and floodplain, riparian planting, and invasive vegetation control.

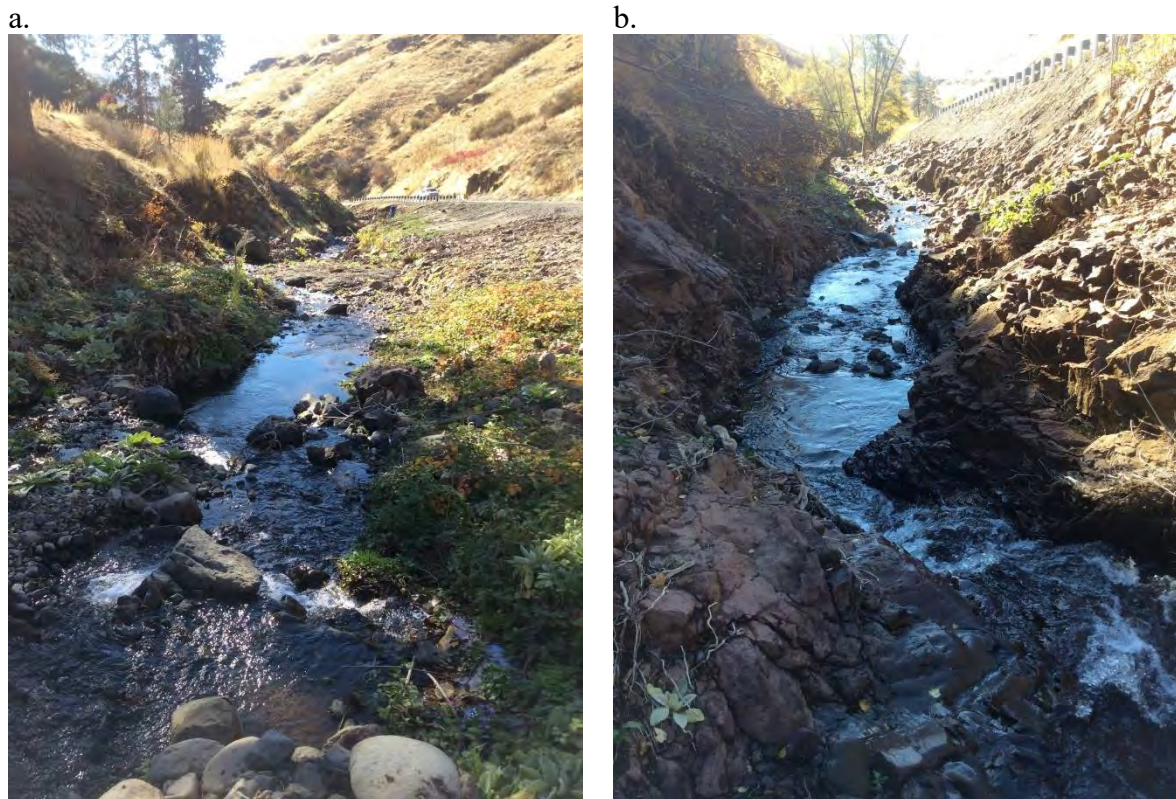
Project Area 02 (PA-02) is located from RM 0.5 to the Highway 129 bridge crossing at RM 1.45 (Figure 3). Confinement is variable, with relatively wide sections (Figure 4a) separated by brief bedrock canyons and deeply incised sections (Figure 4b). The creek flows alongside Highway 129, which increases confinement in localized areas near turnouts. Confined sections are dominated by a step-pool morphology forced by bedrock ledges and large boulders. Wider sections are dominated by a plane bed morphology with occasional multiple threads and brief pockets of diverse hydraulics forced by boulder ribs.

Figure 4. Views looking downstream in Project Area 02 in a relatively wide section (a) and a confined bedrock canyon section (b).

Recommendations for PA-02 are to move lodged LWD into the channel and floodplain in wider sections, reorganize large boulders in bedrock canyon and confined sections, riparian plantings where feasible, and invasive vegetation control.

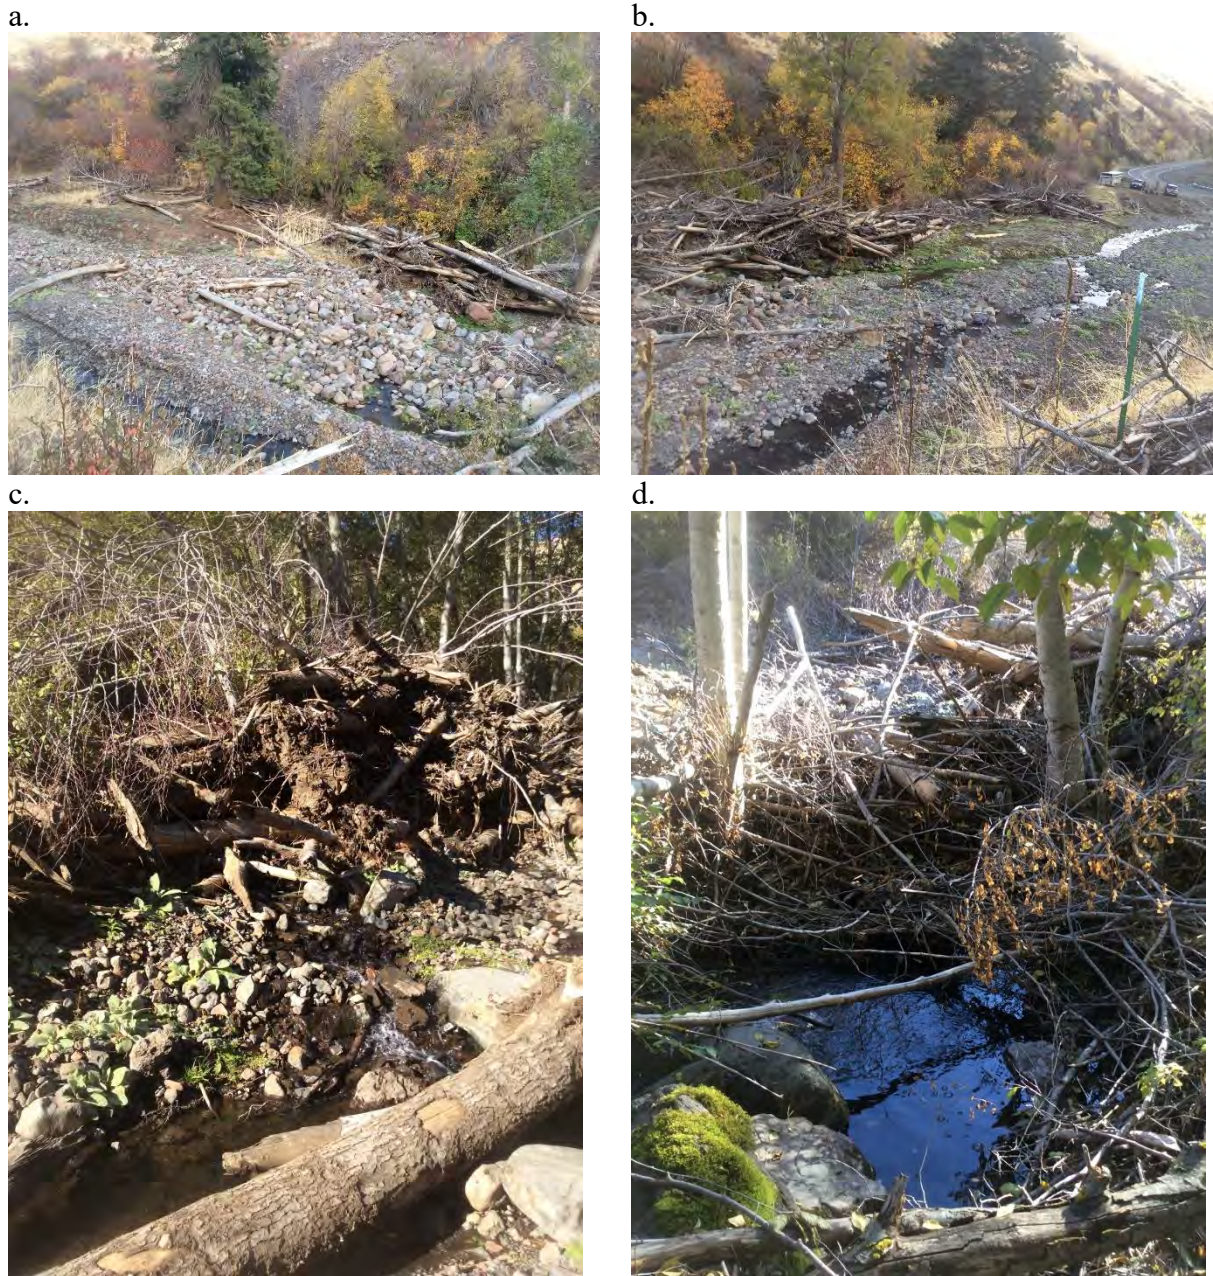
Figure 6. Photos looking upstream (a) and downstream (b) on the mainstem of Rattlesnake Creek near the bottom of the project area and photos looking upstream (c) and downstream (d) of the barrier at the mouth of the West Branch of Rattlesnake Creek.

The bedrock ledge at RM 1.75 is a significant fish passage barrier that cuts off several miles of critical habitat for fish. Even in their current condition, the reaches upstream of the ledge have spawning and rearing potential.

Recommendations for PA-03 are to clear debris away from the mouth of the West Branch of Rattlesnake Creek to improve fish passage, use boulders to improve fish passage over the bedrock ledge at RM 1.75, move lodged LWD into the channel and floodplain, clean up trash debris between RM 1.5 and 1.7, riparian plantings near RM 2.05 and where feasible, and invasive vegetation control.

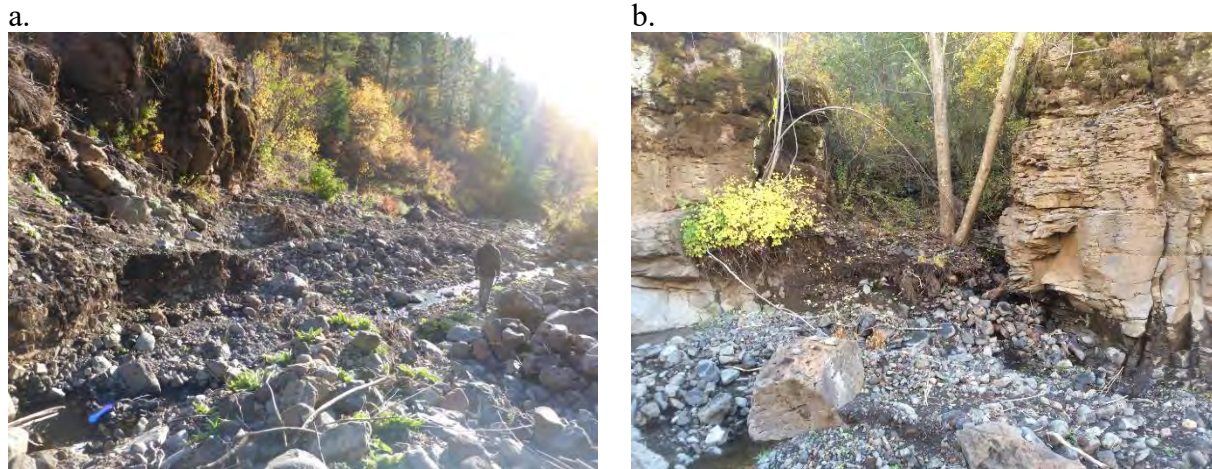
topsoil, removal of LWD, and segments of rapid incision; the channel in PA-04 and the reaches upstream is also heavily impounded by excessive sediment (Figure 8a). Large boulder/cobble berms and sheets cover the entire valley bottom, and the main channel is not well-defined. Substrate in the valley bottom is loose and composed mostly of large size classes, allowing the creek to go subsurface for relatively short segments. A small unnamed tributary on river left is cut off from the mainstem, and marks the top of PA-04 (Figure 8b). There are approximately 50 pieces of lodged LWD along the valley margin.

Figure 8. Representative photo of PA-04 looking downstream showing excessive sediment impacting the channel (a), and the disconnected river left tributary near the top of the project area (b).

The recommendations for PA-04 are to move lodged LWD into the channel and floodplain, move large boulders into the channel, reconnect the unnamed tributary at RM 3.3, riparian plantings, invasive vegetation control, and monitor geomorphic and habitat changes following subsequent high flow events.

Adding LWD and large boulders to the channel will reduce water and sediment transport time and increase hydraulic and geomorphic diversity. Without structural elements, it is likely that the channel will remain in its current condition until the next catastrophic high flow event or will rapidly cut down to bedrock. LWD and boulders locally increase stream competence by creating pinch points, allowing the channel to rework excessive sediment and recreate a naturally-consistent planform.

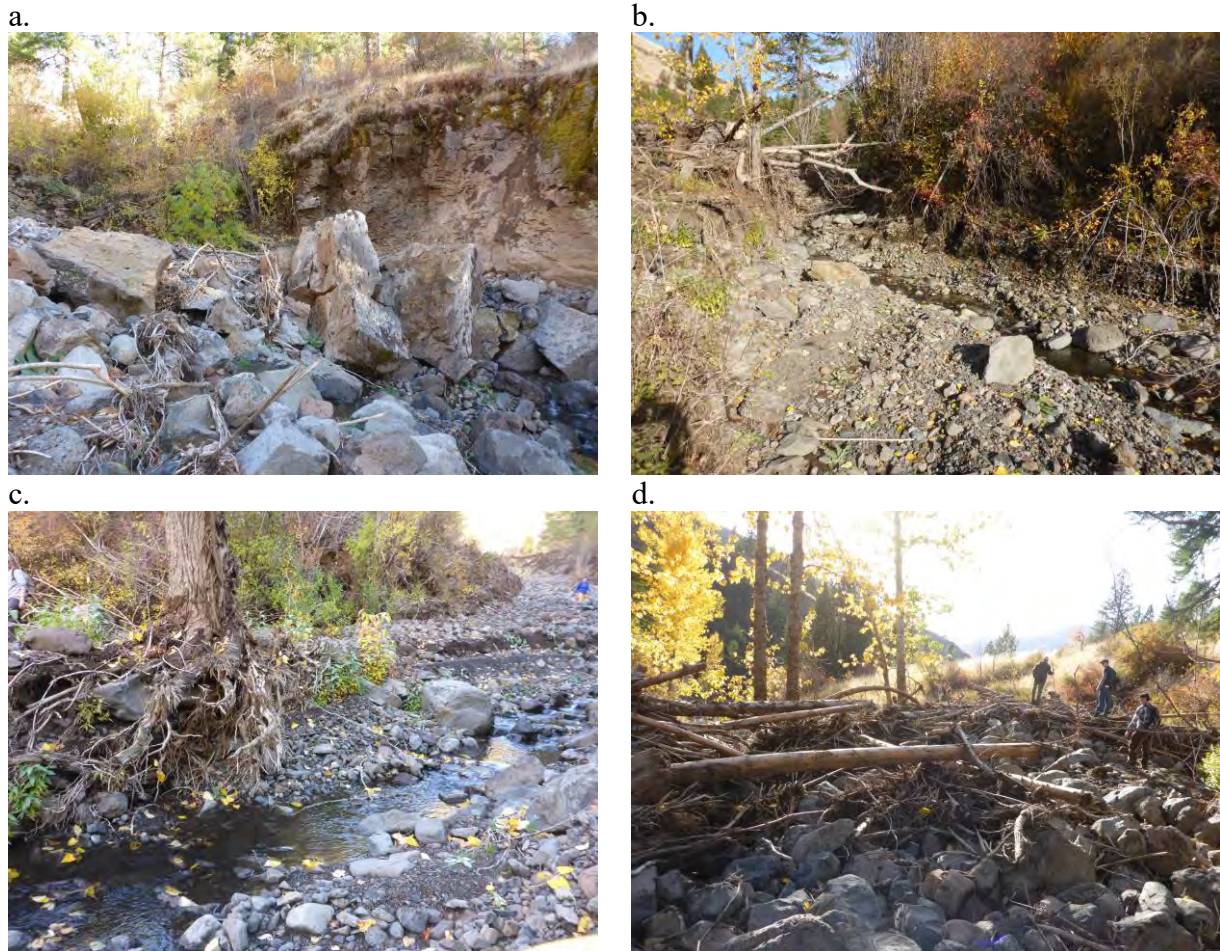
Figure 10. Photos of the complete fish passage barrier at the bottom of the reach (a), typical channel condition and habitat (b and c), and the massive large woody debris jam in the middle of the reach (d).

The chunks of bedrock creating the fish passage at the bottom of PA-05 are holding back a massive amount of sediment. Fully removing the barrier may promote head cutting into the loose substrate upstream; therefore, creating a cascade sequence using boulders and LWD would be a more sustainable option. The LWD jam in the middle of the reach is on top of a boulder sheet, ultimately held in place by a grove of large cottonwood trees. Pulling LWD pieces from the jam and distributing them to nearby channel and floodplain would improve hydraulic and geomorphic diversity at new placement sites. Reorganizing boulders from sheet deposits and placing them in the active channel will improve geomorphic and hydraulic complexity and sediment retention, helping to promote recovery.

Recommendations for PA-05 are to improve passage at RM 3.3, distribute LWD from the jam at RM 3.65 to the surrounding channel and floodplain, reorganize boulders throughout, riparian plantings where feasible, invasive vegetation control, and, if desired by the landowner, repair the private access road on river right from RM 3.75 to 3.9.

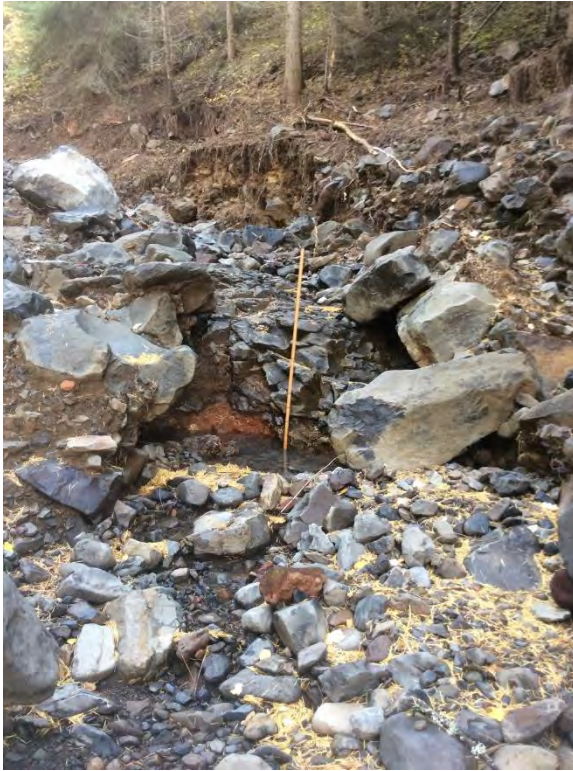
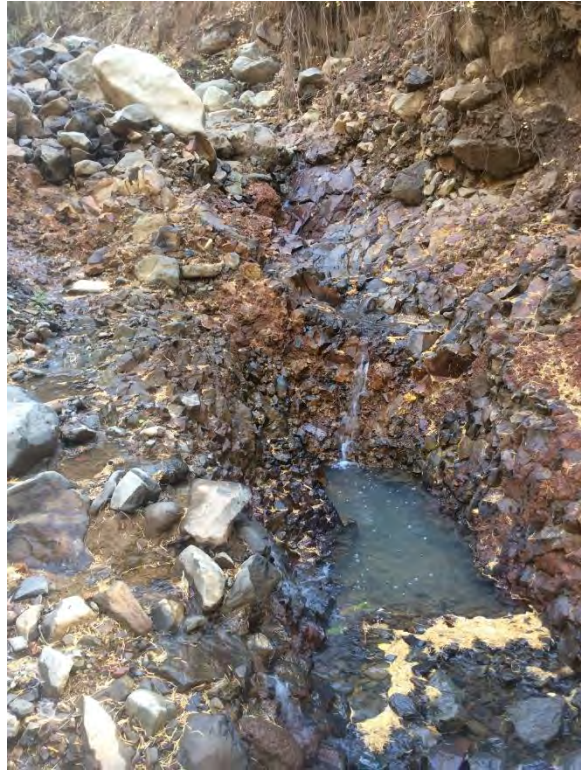
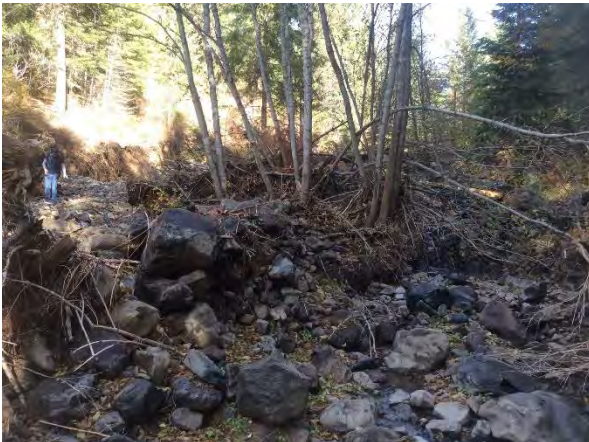
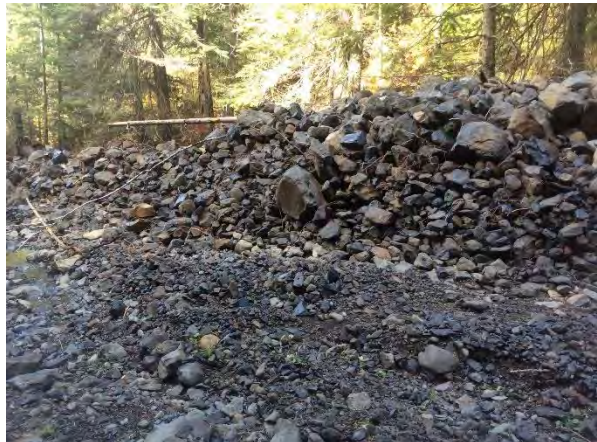
Figure 11. Photos exhibiting the current condition of Reach 4 on Rattlesnake Creek. Bedrock drops (a and b) and large boulder berms (d) are frequent, and the creek goes subsurface over long segments (c).

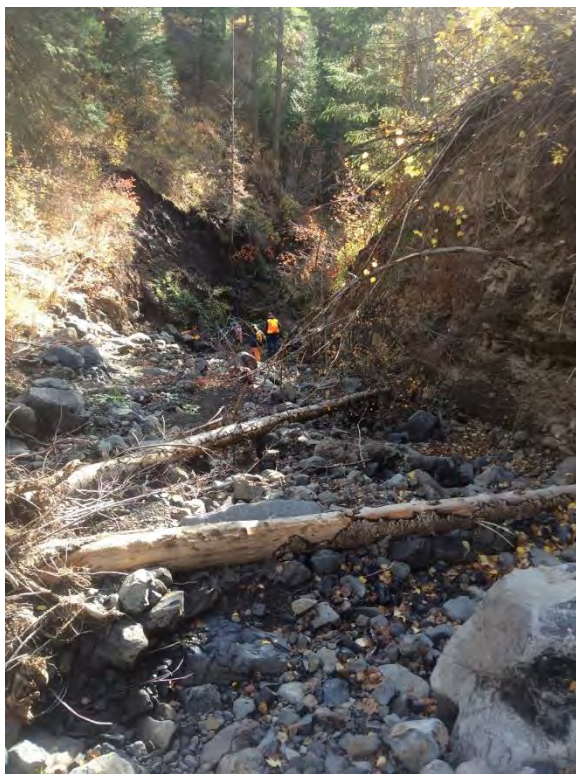
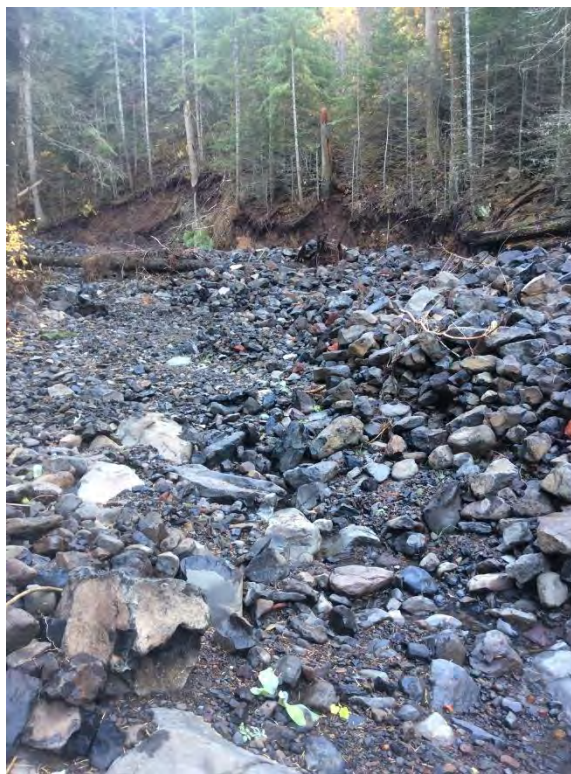
and are currently very active and unstable. There are frequent steep drops in elevation (Figure 13a), tall boulder berms that impose increased confinement on the creek, and excessive sediment composed mostly of boulders and large cobble where the creek goes subsurface (Figure 13b). The creek will require multiple high flow events to define a new, sustainable channel and develop a new floodplain.

Figure 13. Photos looking downstream towards a 20 foot drop in elevation with steep, exposed cut banks (a), and looking upstream along a large boulder berm and excessive sediment where the stream is subsurface (b).

Recommendations for PA-06 are to allow 2-3 years for the creek to rework sediment in the valley bottom and define a new channel, move LWD lodged along the valley margin to the channel and floodplain, reorganize boulders to locally increase stream competence in opportunistic areas, repair/reconnect the access road on river right from RM 4.2 to 4.3, riparian plantings where feasible, and invasive vegetation control. Whether or not early projects are implemented in PA-06, habitat conditions including morphology and sediment characteristics of the channel and floodplain should be closely monitored.

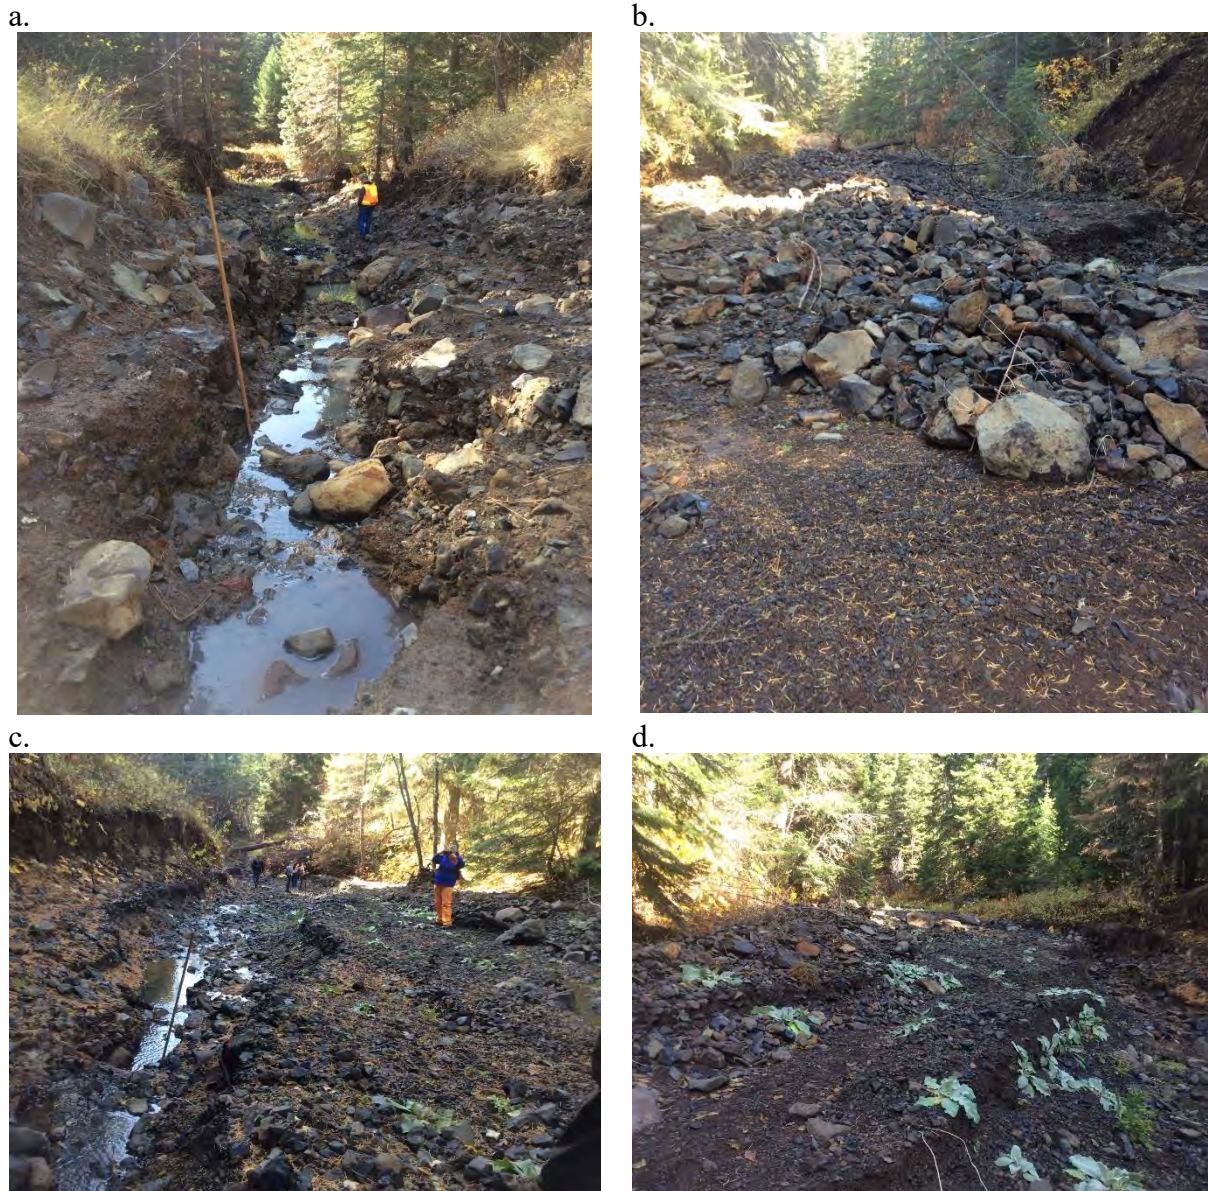
Figure 15. Photos looking downstream at the deeply incised channel near the top of Project Area 07 (a), a massive boulder deposit atop a gravel sheet (b), looking downstream of the incised valley bottom and channel (c), and looking upstream at multiple distinct scour lines and sorted deposits (d).

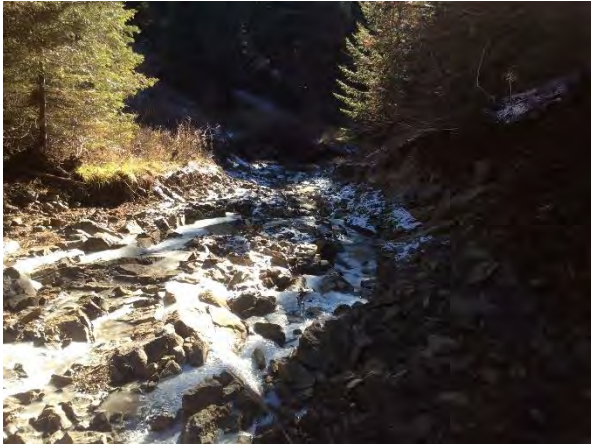
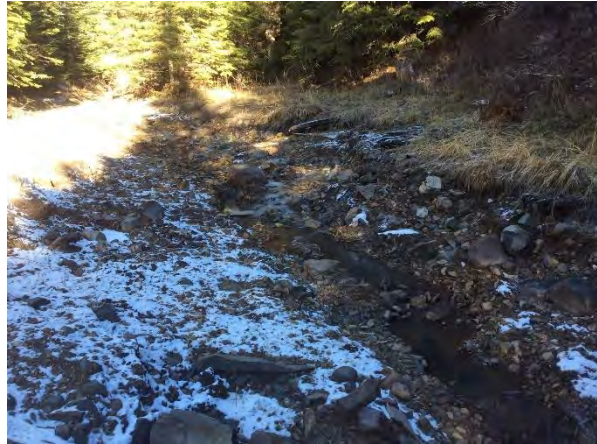
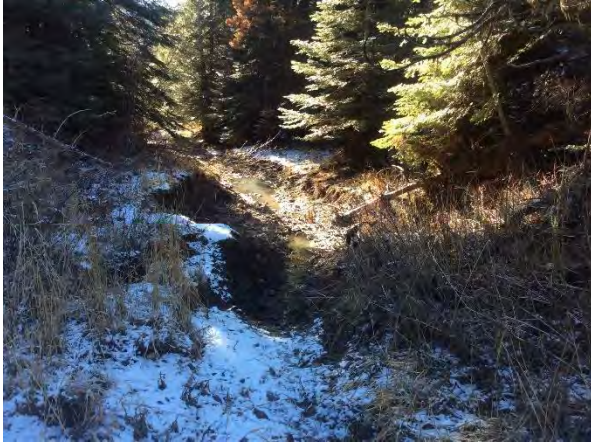
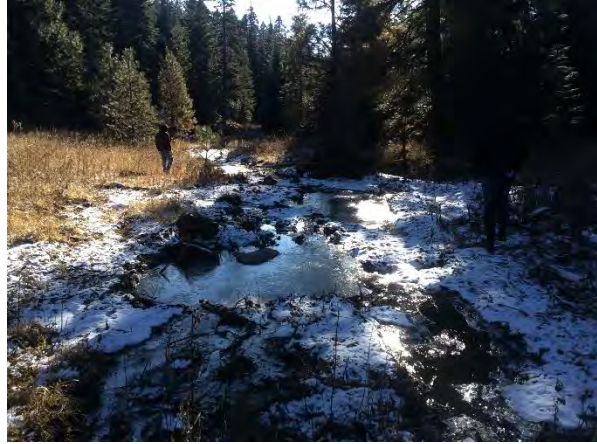
fill meadow (e.g., Figure 17d). Because PA-08 is located high in the basin, there was not a thick layer of topsoil in the valley bottom before the flood, so even though bedrock is exposed in most areas, the overall depth of incision is not as severe as downstream reaches. Regardless of how much topsoil was present, the floodplain is damaged and riparian vegetation is mostly non-existent.

Figure 17. Photos looking downstream of incision down to bedrock (a and b), start of a head cut near RM 6.0 (c), and a low gradient meadow section near the top of PA-08 (d).

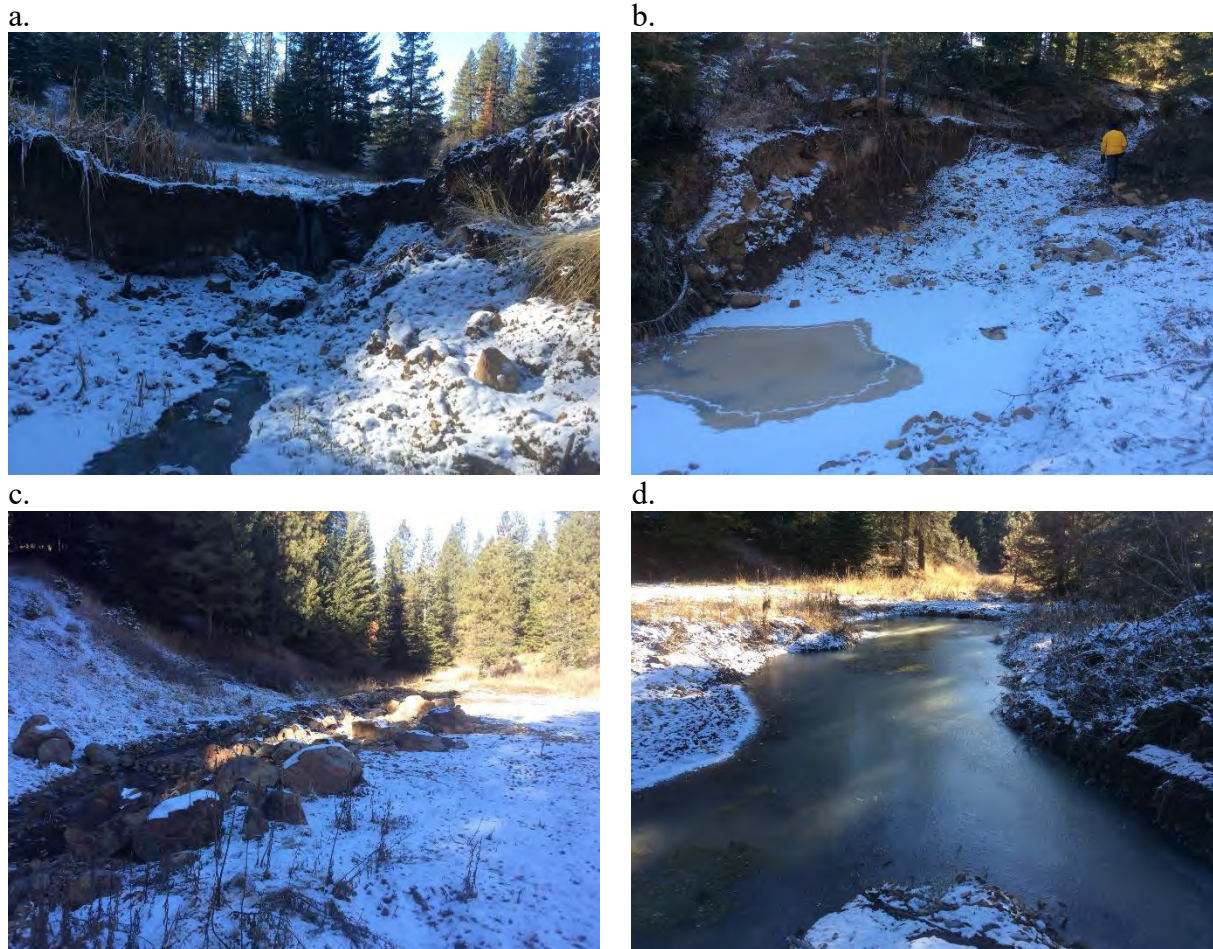
Project Area 09 (PA-09) is the only project area in Reach 5 and is entirely within private lands (Figure 18). The gradient and valley confinement are variable throughout the reach, transitioning between steep confined sections, and unconfined meadows. A pond near RM 6.5 was damaged by the flood, but remains partially intact (Figure 19a). Downstream of the pond, the valley bottom is scoured down to bedrock (e.g., Figure 19b) in most areas until the channel reaches a private road crossing near RM 6.3. A large boulder sheet was deposited downstream of the road, extending downstream nearly 0.2 RM. Some work has already been done to repair damages from the flood including creating a small dike along the channel near RM 6.2 (Figure 19c). There are several private roads with access to the parcels affected by the flood. Two roads with culverts cross the channel and both were damaged, but have been fixed or replaced. The lower culvert is clogged with sediment and backing up water upstream of the road crossing (Figure 19d). Material in the culvert appears to be mostly fines, sands, and gravel, so it may clear itself during the next high flow event; however, if the sediment is not cleared, more damage could be caused to the road and downstream reaches.

Figure 19. Pictures of PA-09 looking at damage at the lower pond (a), excessive erosion downstream of the pond (b), a small dike made from boulders deposited after the flood (c), and a clogged culvert backing up water upstream of a road crossing (d).
